**United States Air Force  
611 Air Support Group  
611 Civil Engineer Squadron**

**Indian Mountain LRRS,  
Alaska**

**MANAGEMENT  
ACTION PLAN**

**JUNE 1995**

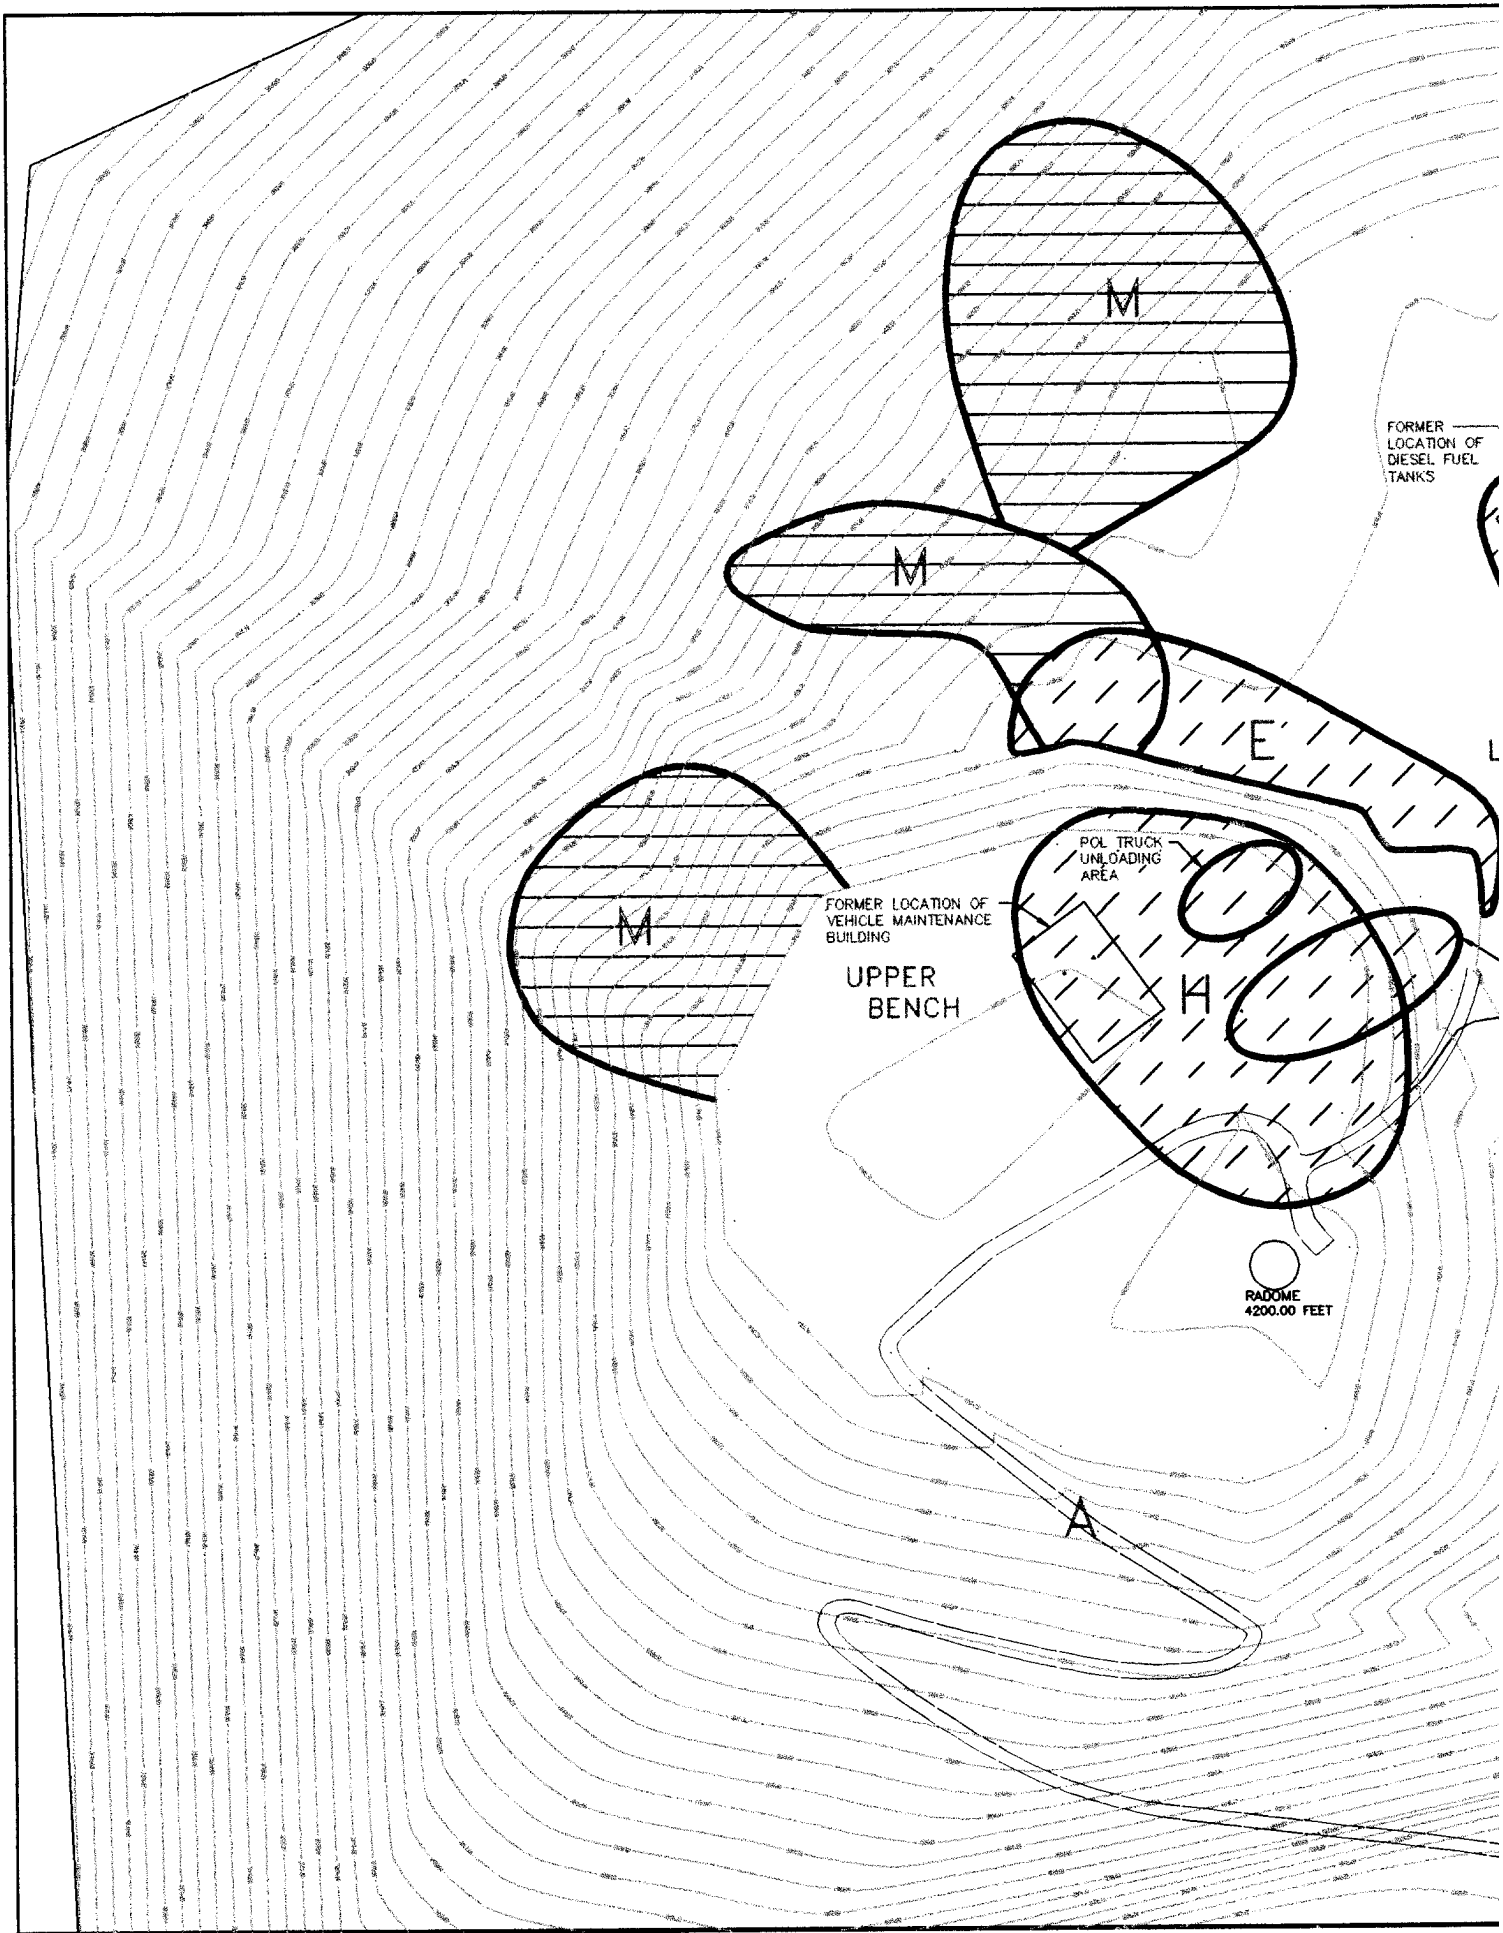
LOCATION OF PAST HAZARDOUS  
SUBSTANCES ACTIVITIES  
UPPER CAMP

backup generator. At Lower Camp, existing structures include the industrial-residential composite facility, two storage buildings, a pump house, and several aboveground fuel tanks. Table 1-2 presents a history of installation operations at Indian Mountain LRRS. Figures 1-2 and 1-3 present locations of past hazardous substances activities at the installation. Letter coding on these figures corresponds to the MAP column of Table 1-2.
